Results from the latest Indium modules

R. Bates, D. Smaranda, K. Doonan

Indium bumps

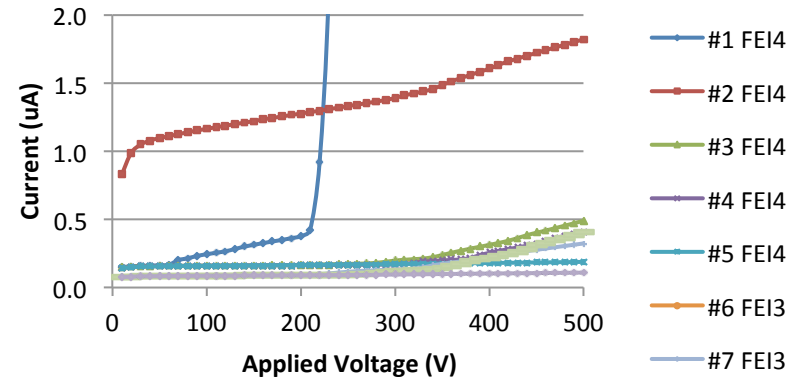
On wafer IV. Current against Voltage for Wafer 2873-8 (300um, N in P type).

- IV characteristics not matched up
- But obviously much worse
- Something to worry about regarding scratches on sensors during processing

Device	I Plateau	Vbk
14-07-24-S2	2uA	40V
14-07-25-S2	1uA	20V
14-07-25-S4	4.4uA @ 40V	Linear increase

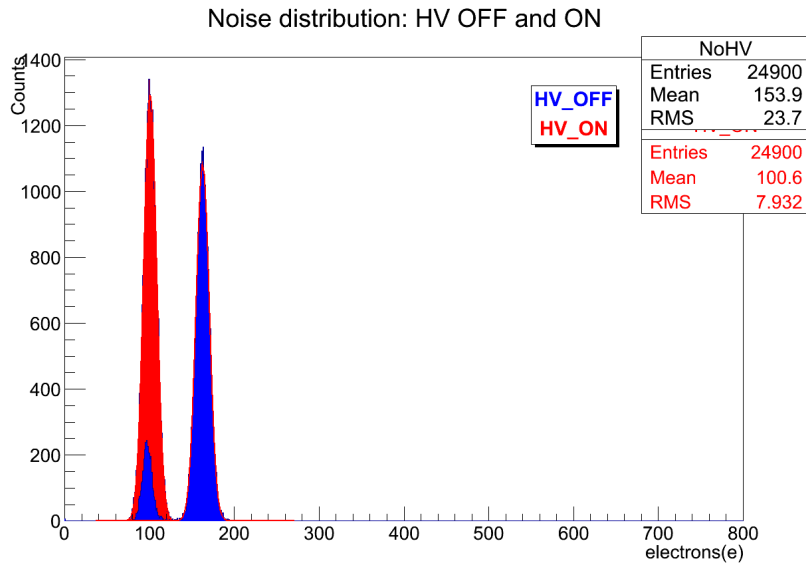
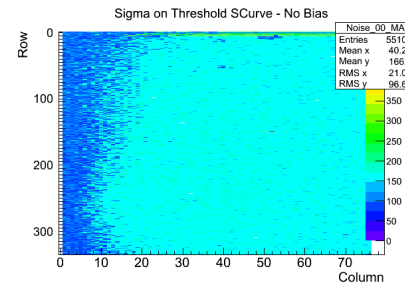
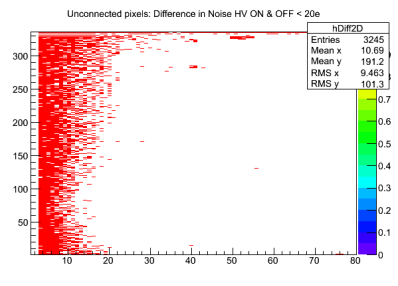
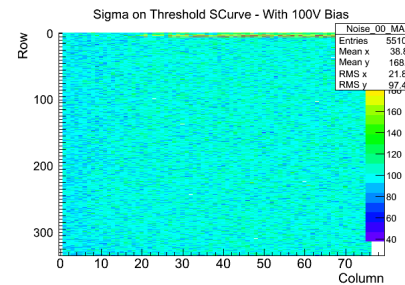
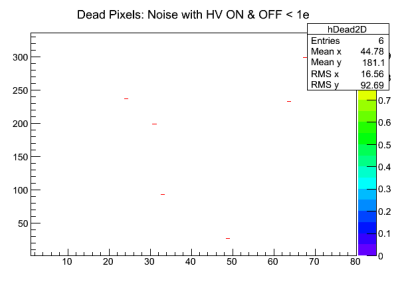
14-07-24-S2

20kg Bond force

Significant number of unbonded channels, 3245

Zero cross talk, HV on -> no merged bumps

Am-241 gams source test on RCE showed the same un-bonded channels

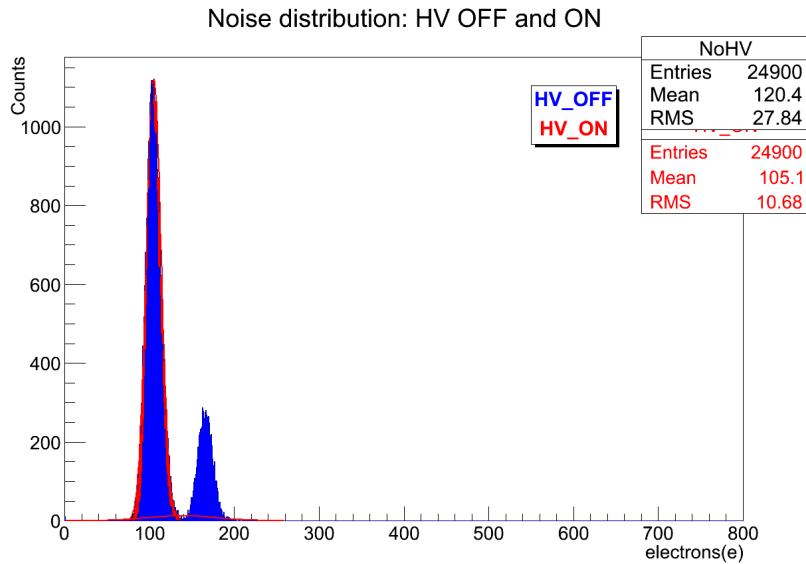
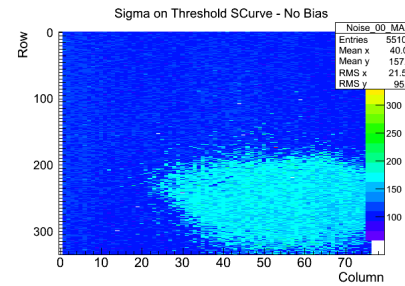
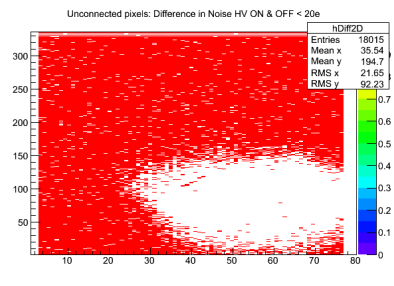
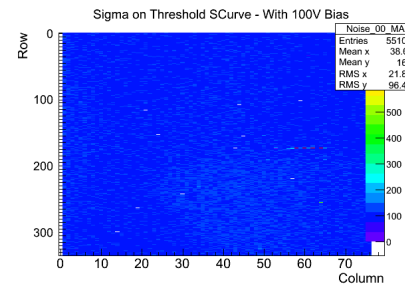
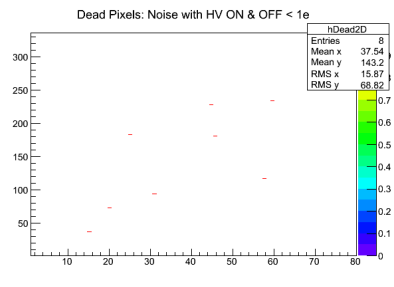
14-07-25-S4

5kg Bond force
Very Significant number of unbonded channels, 18015
Zero cross talk, HV on -> no merged bumps
