Pictures on FE-I4B wafers

S. Vähänen 23.5.2013 Advacam

Darkened Al Pads on FE-14 ROIC Wafers

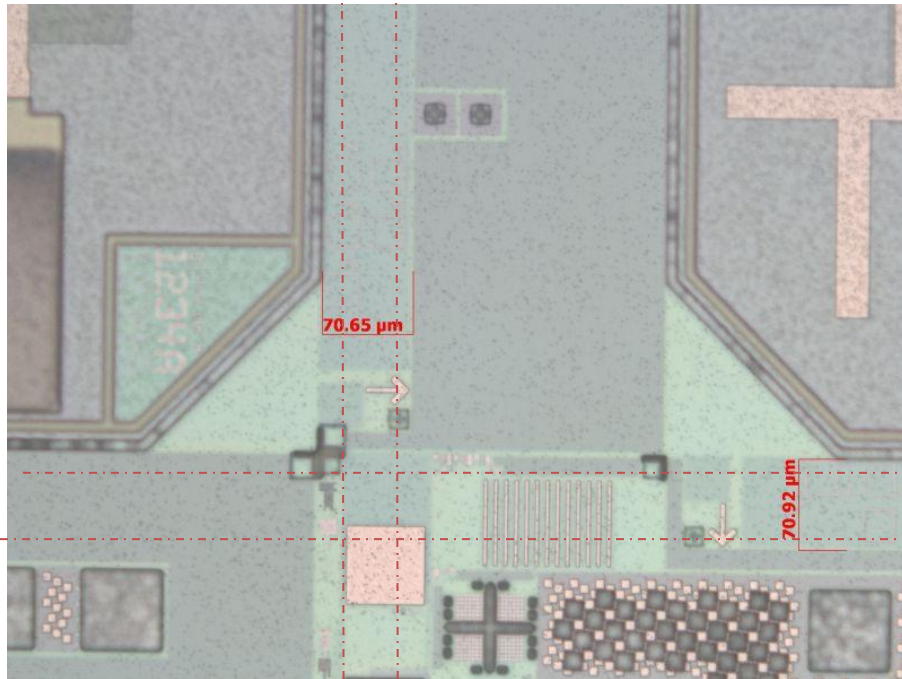
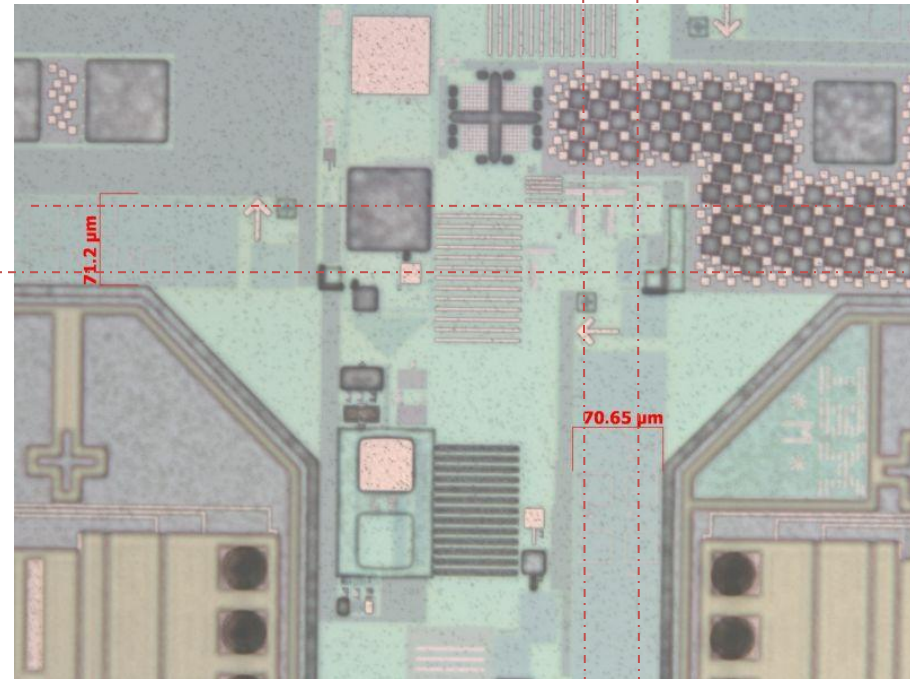
- All the exposed aluminum structures have become dark (rough) during the bumping process
 - Sami's best guess: wet etching chemistry of adhesion layer hasn't been compatible with Al pads
- Effect can be seen all over the wafer
- Wire bondability has been compromised
- Dicing was scheduled for this week
 - What is the next move?

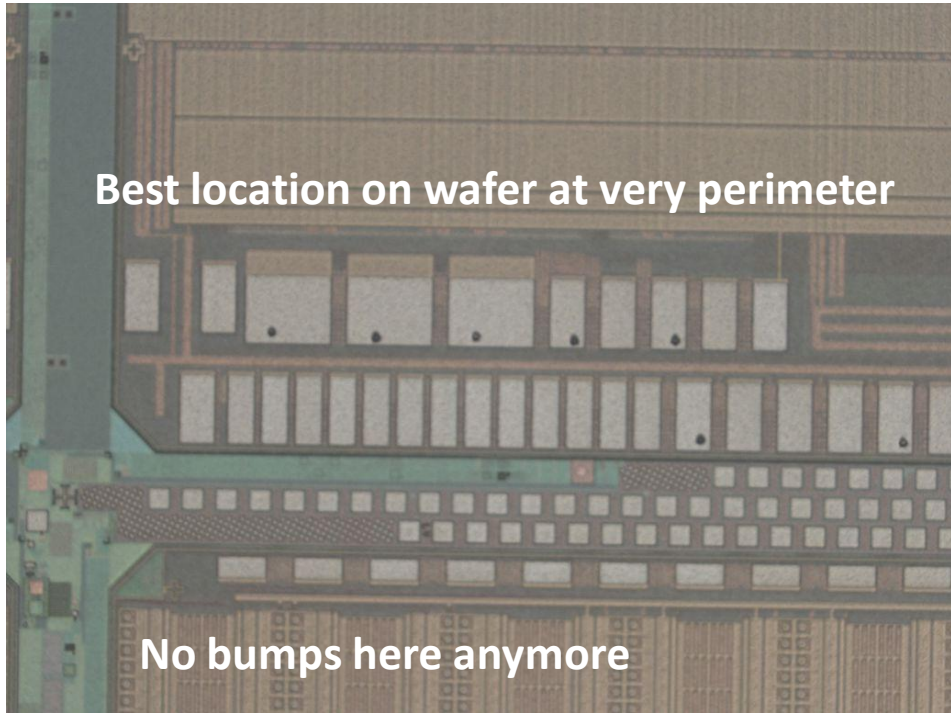
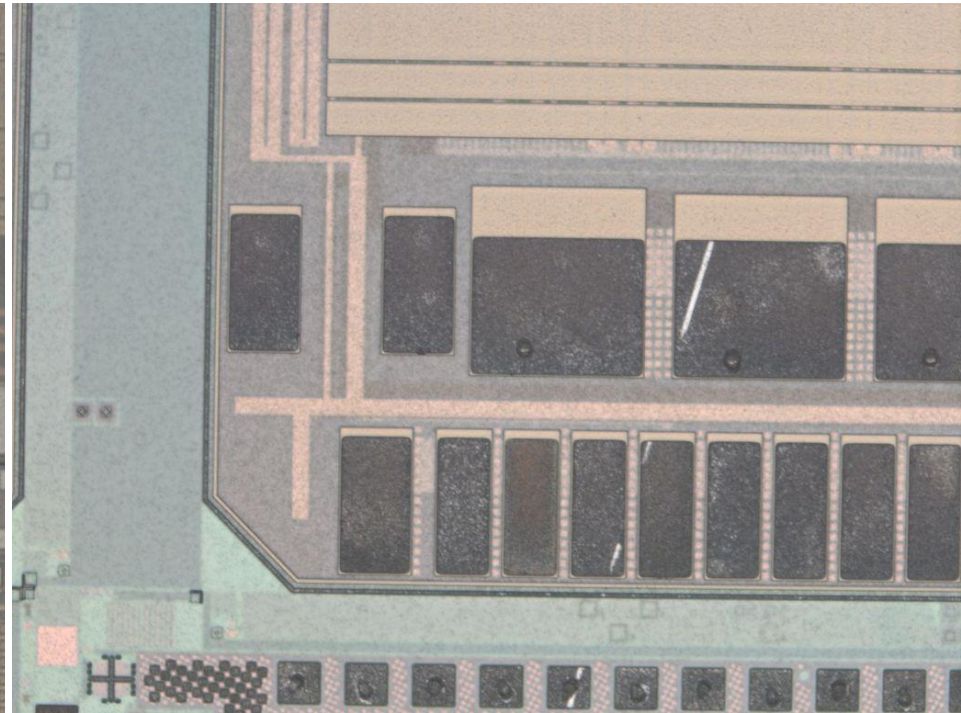
W#WMB8WDH

Best location on wafer at very perimeter

No bumps here anymore
