Project Name: FE-I4_proto
Project Number: 75909

Readout Wafer Cracked at Tape Removal
(Wafer ID V6ABC1H)

Date: March 16, 2012

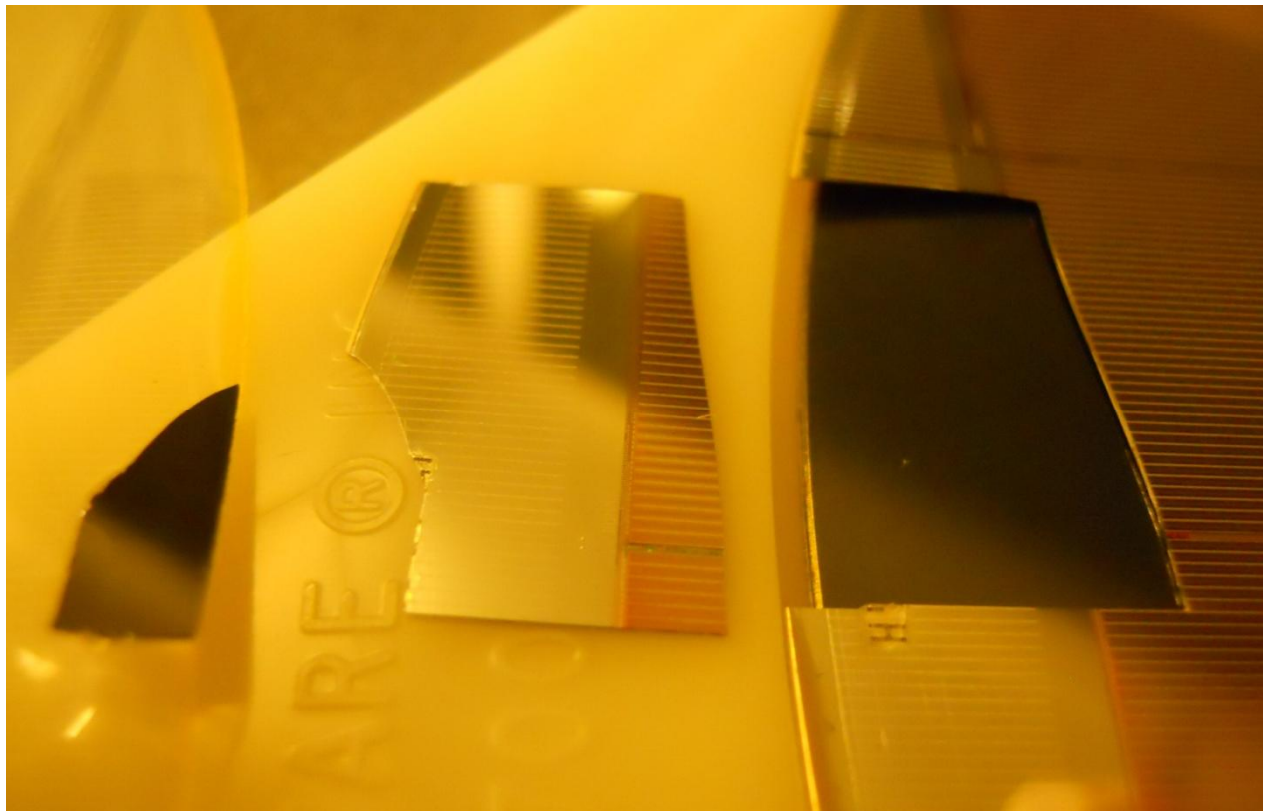
Readout Wafer (V6ABC1H) in Three Pieces After Tape Removal

- A small piece (with wafer ID) still on tape (left), a larger loose piece (center), and the rest of the wafer (right).

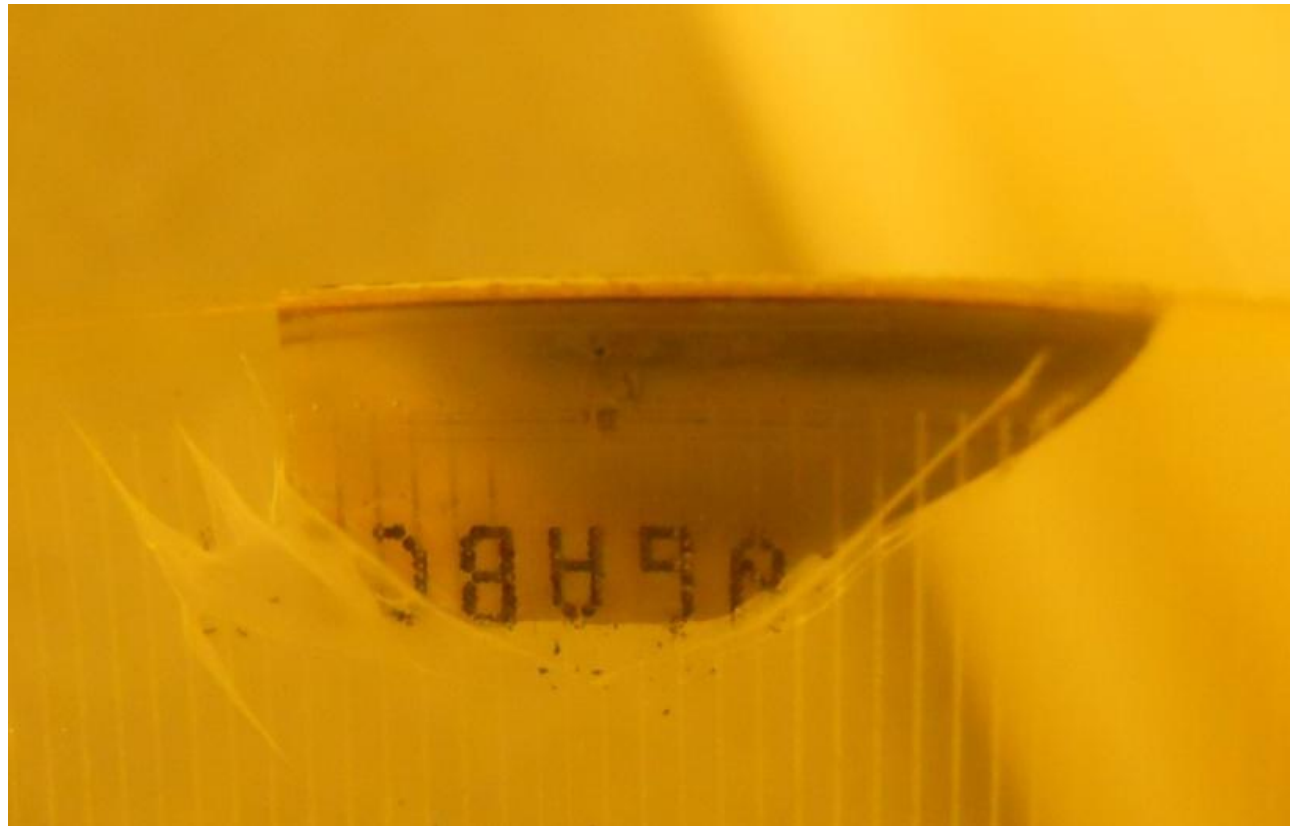
Tape Stuck on Wafer ID (V6ABC1H)

- Laser-engraved wafer ID on a small chipped-off piece of wafer as seen through tape.
