Results from the latest Indium modules

R. Bates, D. Smaranda, K. Doonan

Indium bumps

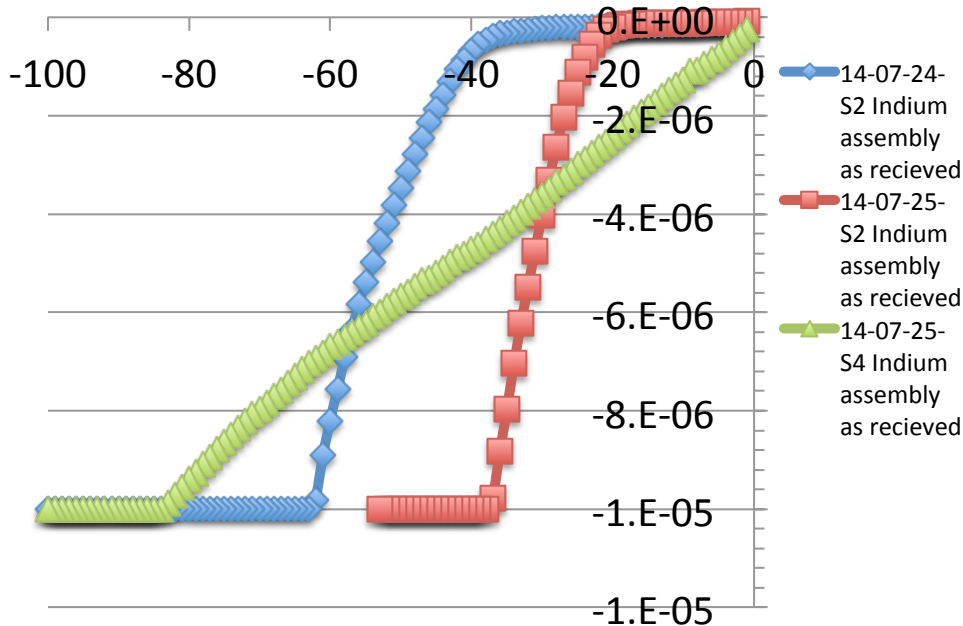
On wafer IV. Current against Voltage for Wafer 2873-8 (300um, N in P type).

- IV characteristics not matched up
- But obviously much worse
- Something to worry about regarding scratches on sensors during processing

Device	I Plateau	Vbk
14-07-24-S2	2uA	40V
14-07-25-S2	1uA	20V
14-07-25-S4	4.4uA @ 40V	Linear increase
